Manhole Inspection Summary

Manhole # S27EE_020MH

Insp Date: **11/21/07 12:18 PM**

Location Address: **1525 PENNSYLVANIA AVE** Cross Street: **MCMECHEN ST**

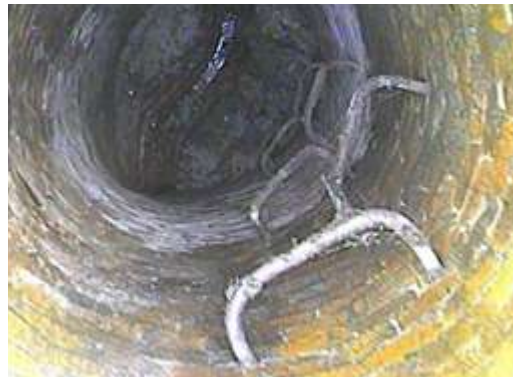
Defect 2

Steps Count: **7** Missing: **0** ☒ **Corroded**

CORRODED STEPS

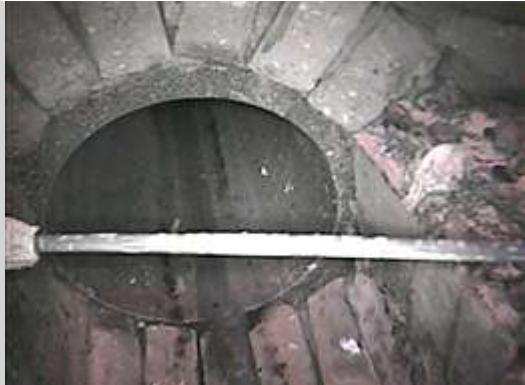
12 O'Clock Outflow

10 in. Circular Gravity Sewer
Pipe Out @ 12 O'Clock

DEBRIS ON BECNH

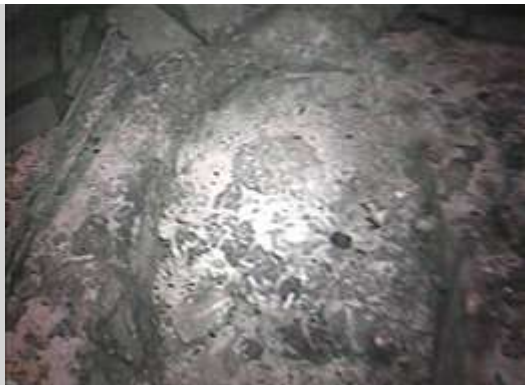
3 O'Clock Inflow

8 in. Circular Gravity Sewer
Pipe In @ 3 O'Clock

Connects To: **Stub connection / abandoned**

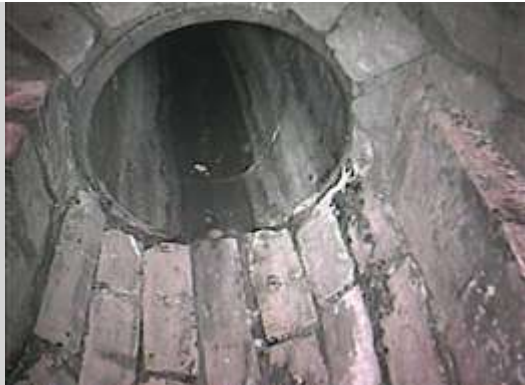
6 O'Clock Inflow

10 in. Circular Gravity Sewer
Pipe In @ 6 O'Clock
